Manhole Inspection Summary

Manhole # S06GG2015MH

Insp Date: **10/23/06 12:00 AM**

Location Address: **7126 PARK HEIGHTS AVE**

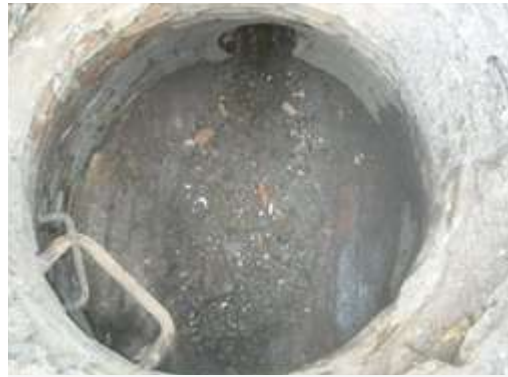
Top View

Corroded steps. Channel debris.

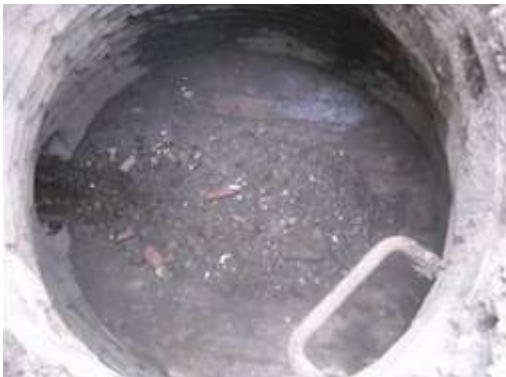
Defect

Barrel infiltration.

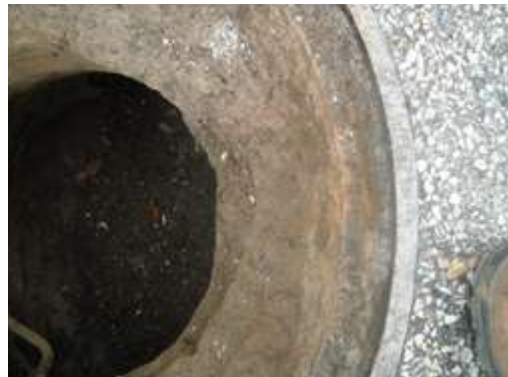
Defect

Frame leaks. Frame offset. Adjustment infiltration.

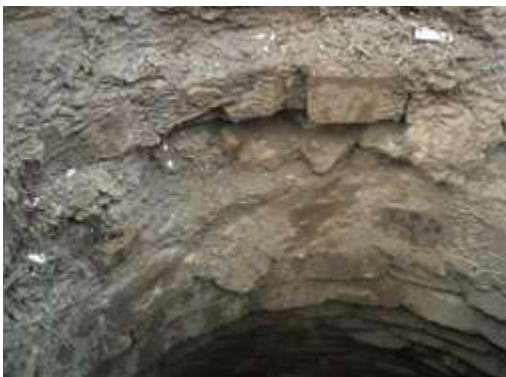
Defect

Frame leaks. Frame offset. Adjustment deterioration and infiltration. Corbel infiltration - other side.

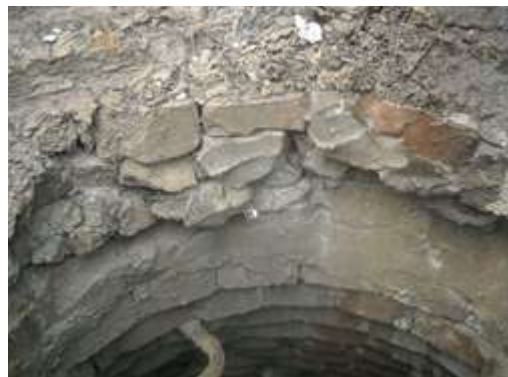
Defect

Frame leaks. Frame offset. Adjustment deterioration and infiltration. Corbel infiltration.

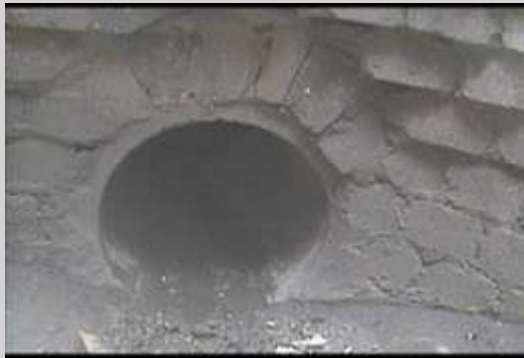
10 in. Circular Gravity Sewer
Pipe Out @ 12 O'Clock

Deposits: ☐ None ☒ **Mud** ☐ Sludge ☒ **Debris** ☐ Grease

Silt Depth: **0.5** (in.) Deposits Extent: **Light**

Infiltration: **None** Pipe Seal Cond: **Cracked**
